MANAGING WATERSHEDS FOR HUMAN AND NATURAL IMPACTS

PROCEEDINGS OF THE 2005 WATERSHED MANAGEMENT
CONFERENCE

Postfire Rehabilitation Treatments: Are We Learning What Works?

P. R. Robichaud¹ and R. E. Brown²

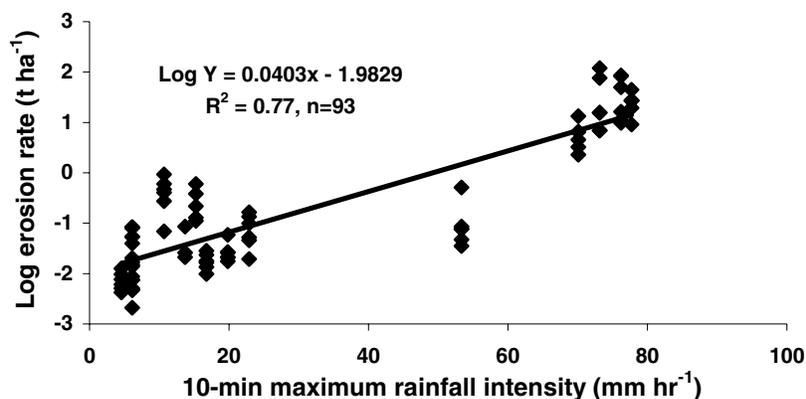
Figure. 1. Ten-minute maximum rainfall intensity vs the log of the erosion rate as measured with sediment fence plots after the 2000 Bitterroot Complex Fire.

Within a watershed, sediment and runoff responses to wildfire are often a function of burn severity and the occurrence of hydrologic events. Even severely burned areas will have minimal soil loss in the absence of rainfall. However, when a major rainfall event follows a large, high burn severity fire, large-scale hydrological responses and erosion are likely. In particular, high-intensity, short-duration rainfall has been associated with high stream peakflows and significant erosion events after fires (DeBano *et al.* 1998; Neary *et al.* 1999). After the Buffalo Creek Fire in the Colorado Front Range, Moody and Martin (2001) measured 30-minute maximum rainfall intensities (I_{30}) that were greater than 60 mm hr^{-1} . Short duration rainfall events of such intensity tend to exceed the average infiltration rates of many soils. Recent data from the 2000 Bitterroot Complex Fires indicate the rainfall intensity may be more significant than rainfall amount or duration (Fig. 1), with significantly greater erosion occurring when 10-minute maximum rainfall intensity (I_{10}) exceeds 50 mm hr^{-1} (Spigel 2002).

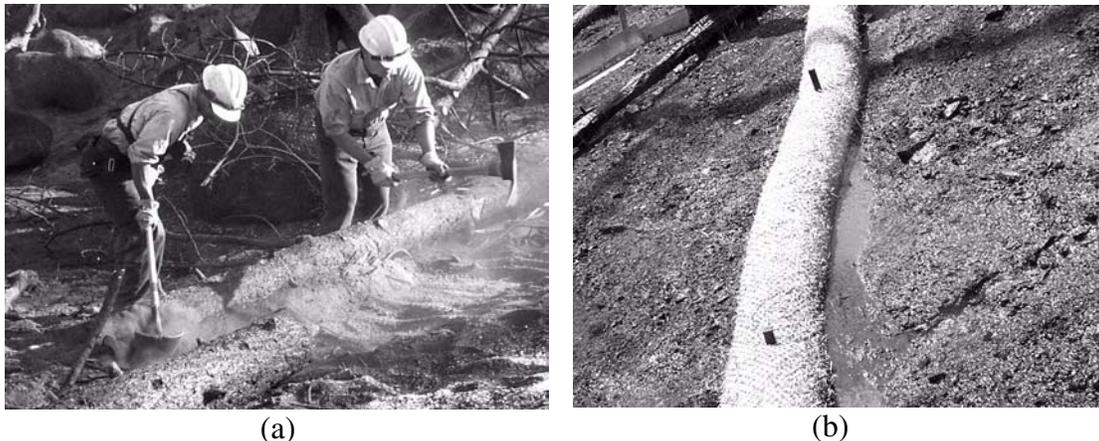
Figure 2. (a) Fire crews install a contour-felled log erosion barrier in a research catchment after the 1999 Mixing Fire (California, USA). (b) A straw wattle erosion barrier is tested during a rainfall simulation experiment following the 2000 Bitterroot Complex Fire (Montana, USA).

Erosion Barriers—Straw wattles, contour-felled log erosion barriers, and other natural and engineered structures have been used to provide a mechanical barriers to overland flow, promote infiltration, trap sediment, and thereby reduce sediment movement on burned hillsides. Contour-felled log erosion barriers have been widely used in areas where fires leave dead trees that can be felled, placed along the contours of burned hillslopes, staked in place, and the gaps between the logs and soil surface filled with additional soil to prevent underflow (Fig. 2a) (Robichaud *et al.* 2000). Some recent installations have included the construction of soil berms at the end of the logs to increase their storage capacities. Straw wattles, 0.25 m diameter nylon mesh tubes filled with straw, are permeable barriers used to detain surface runoff long enough to reduce flow velocity and provide for sediment storage (Fig. 2b). Turning 0.6 m at each end of the wattle upslope can increase the sediment holding capacity. Straw wattles are a good alternative in burned areas where logs are absent, poorly shaped, or scarce.

The potential volume of sediment stored on a hillslope treated with erosion barriers is highly dependent on slope, barrier diameter and length, construction of earth berms at the ends of the barriers, and ‘quality of installation’—i.e., the degree to which the barriers are adequately staked, aligned perpendicular to the flow path, and maintain ground contact throughout their length. The length of time the treatment remains functional depends on post-installation rainfall parameters (especially rainfall intensity), density of barrier installation (i.e., volume of sediment holding capacity per ha), soil erodibility, and topography. In some instances contour-felled log erosion barriers have filled with sediment following the first several storm events after installation, while others have taken 1 to 2 years to fill (Robichaud 2000).

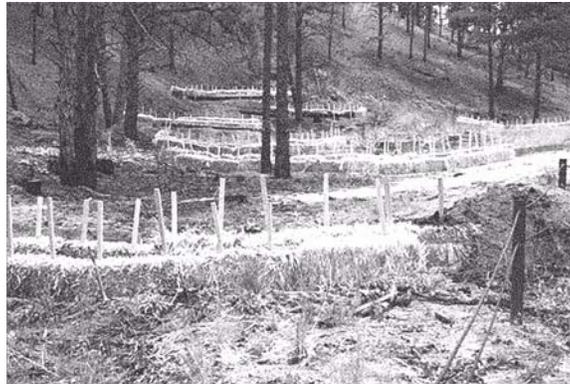
Figure 3. Straw bale check dams installed after the 2002 Hayman Fire in Colorado.

Straw bale check dams are inexpensive, easy to install, and effective at trapping sediment but eventually deteriorate due to climatic conditions, streamflows, or cattle and wildlife disturbance (Fig. 3). Straw bale check dams are often fill in the first few storms, so their effectiveness diminishes quickly and they tend to fail in large storms. Collins and Johnston (1995) evaluated the effectiveness of straw bales on sediment retention after the Oakland Hills fire. About 5000 bales were installed in 440 straw bale check dams and 100 hillslope barriers. Three months after installation, 43 to 46 percent of the check dams remained functional.
