A Case Study of a Community Affected by the Witch and Guejito Wildland Fires

Alexander Maranghides and William Mell, Building and Fire Research Laboratory, National Institute of Standards and Technology, Gaithersburg, MD, USA*

Abstract. Wildland-urban interface (WUI) fires occur when fire spreads through both wildland and community (structures and vegetation) fuels. These fires are capable of causing significant destruction to both the built and the natural environments. When these fires occur under extreme fire danger conditions (e.g., high winds, low humidity) and in areas of significant population (e.g., San Diego, California) firefighters, and other emergency responders, are significantly challenged by the combination of firefighting and aiding the public. This paper presents the results of an in-depth case study of a community of 274 residences which was subjected to two wildland fires (within 2.5 h of each other) during the October 2007 firestorm in southern California. A significant amount of effort was spent obtaining information from residents and emergency responders to determine the fire spread timeline, structure ignition mechanisms, and defensive actions. Of the 274

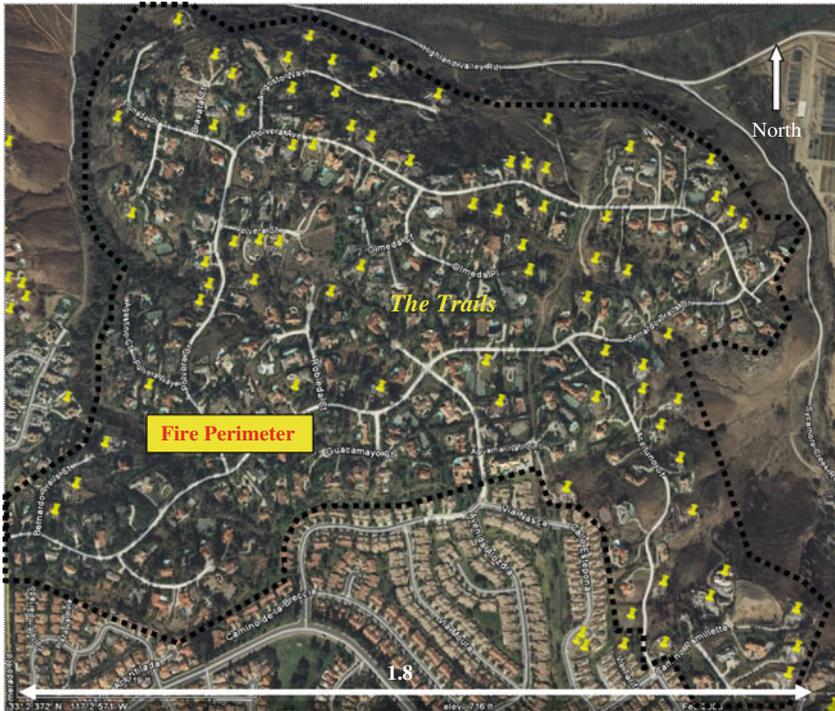
Figure 1. The Trails community, destroyed homes (in yellow) and fire perimeter after the Guejito and Witch fires.

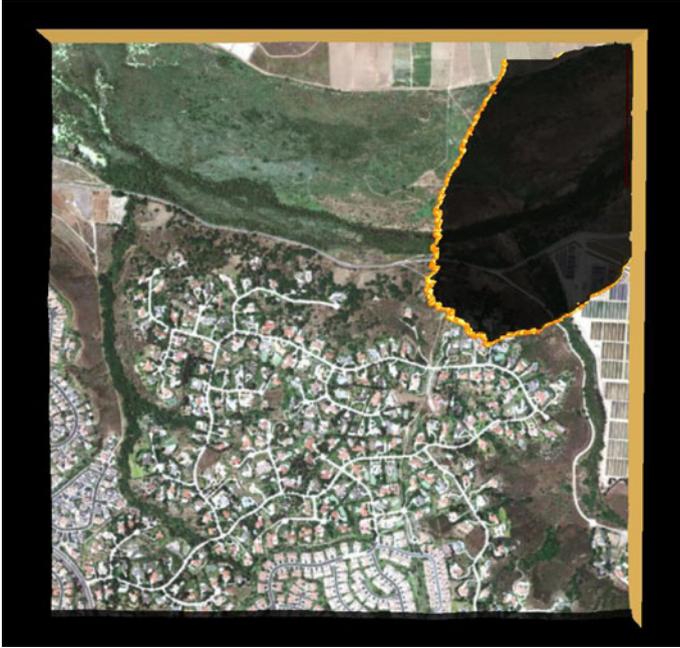
Figure 2. This figure is an image from a computer simulation of a fire spreading in the Bernardo Trails area. The computer simulation tool is called WFDS (Wildland-urban interface Fire Dynamics Simulator). The image shows the results from an initial stage of applying the WFDS to study the 2007 fires in the Bernardo Trails area. The horizontal extent of the computational domain is 2000 m by 2000 m. The wind is from the northeast at 20 m/s (which approximates Santa Ana conditions). The WFDS is capable of accounting for the presence of vegetation, structures, terrain, roads, and other fuel breaks using LiDAR and other imagery. In this figure an image from Google Maps is put on the terrain for ease of visual reference.

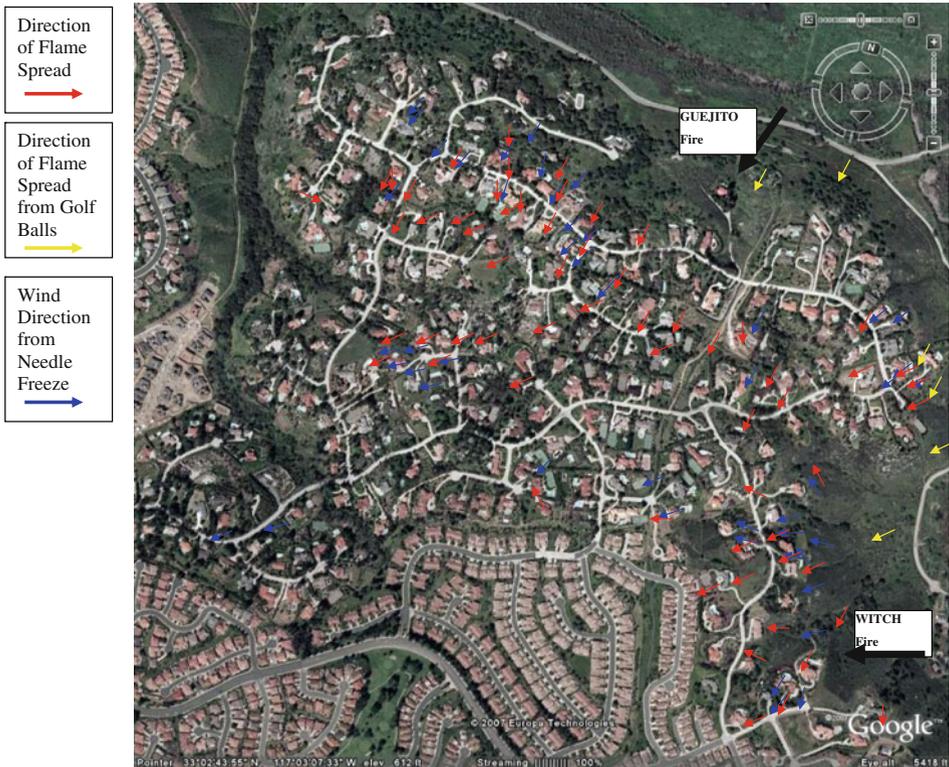
Figure 19. The Trails—flame spread and needle freeze.

Needle freeze information, the process of dehydrated foliage aligning or “freezing” parallel to the wind direction, was also used to obtain wind direction [24]. Flame spread direction indicators such a V patterns of burned vegetation and burn damage around the leeward side of trees were collected in and around The Trails. Figure 19 illustrates flame spread and needle freeze around and within The Trails.

Figures 18, 19 and 21 illustrate the fire line progression within The Trails. The fire lines, represented by solid lines in Figure 21, are assembled by joining together the observations at different times throughout the community. A fire line data point is associated with either vegetation or a structure burning. The two earliest reports of fire in the community occur at 2:30 in the morning, over an hour

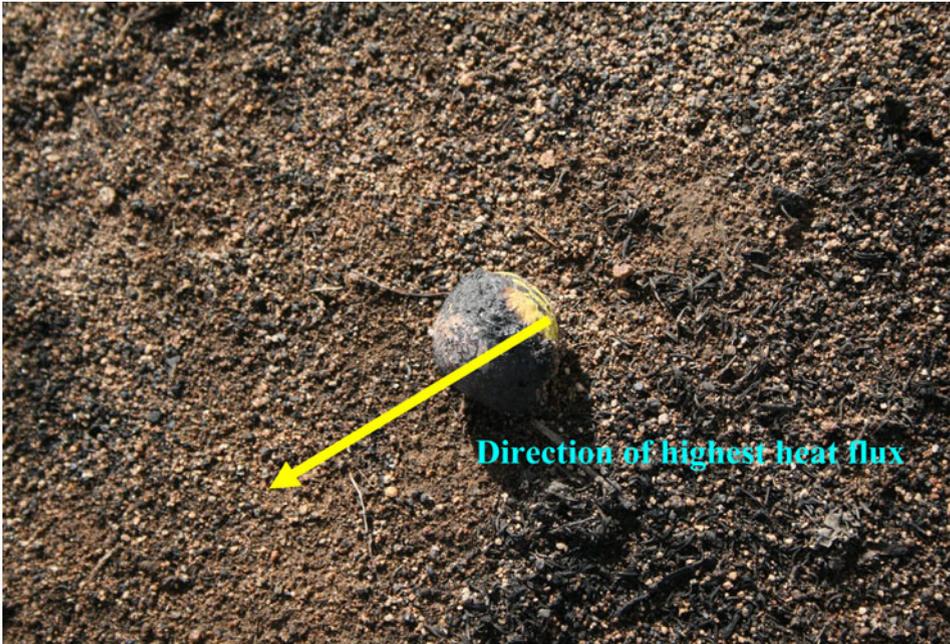
Figure 20. Golf ball providing direction of highest heat flux.

A survey of the perimeter of The Trails and valley floor identified a number of golf balls that were partially embedded in the ground. These were used to obtain general quantitative information of the direction of the oncoming fire front, or highest heat flux, since the surface of the golf ball facing the direction of the oncoming fire front melted (Figure 20). GPS coordinates and a compass heading were used to document this information. The yellow arrows in Figure 18 depict the information collected from the geo-located golf balls. The general flame spread direction information obtained from the golf balls is consistent with the other flame spread information collected from first responders.

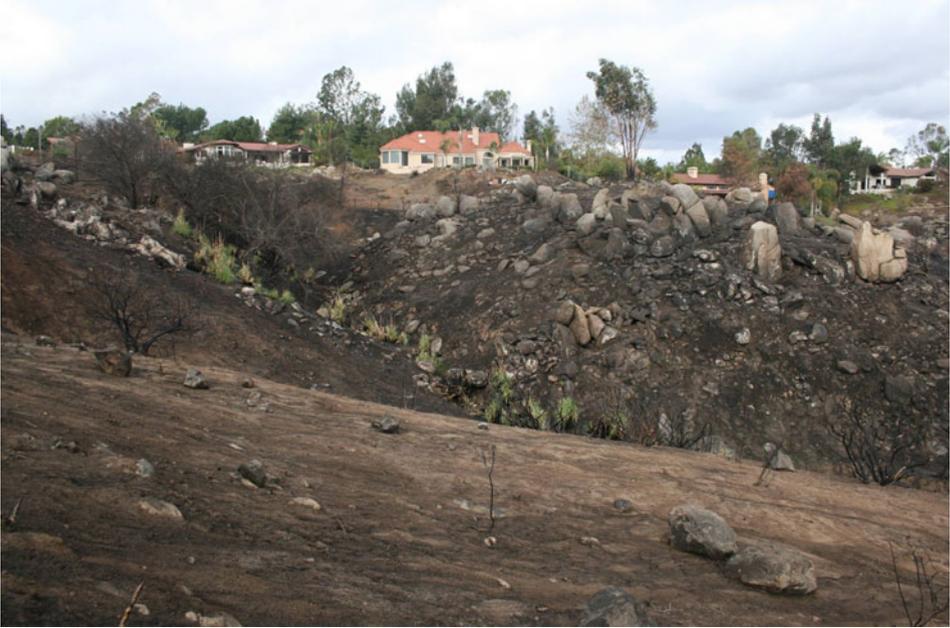
Figure 22. Rock outcrop acting as a fire break.

northern perimeter, the fuels consisted of intermixed hardwoods and brush. At the eastern end of Polvera Avenue there is a rock outcrop (see Figure 22). This outcrop reduced the local wildland fuel loading and provided a fire break for the structures to the north (up slope) of it.

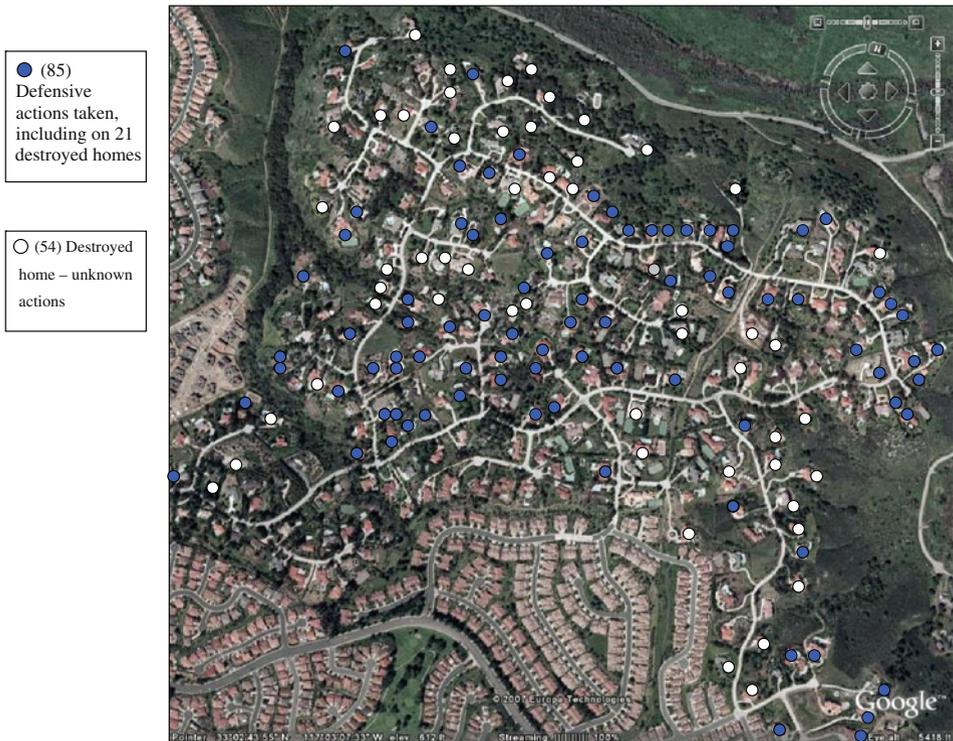
Figure 23. The Trails defensive actions.

The focus of the analysis is on all actions taken shortly before the approach of the Guejito fire and for ~ 12 h after its arrival, or until 3:00 pm Monday afternoon. Figure 23 illustrates the impacts of the identified defensive actions taken at

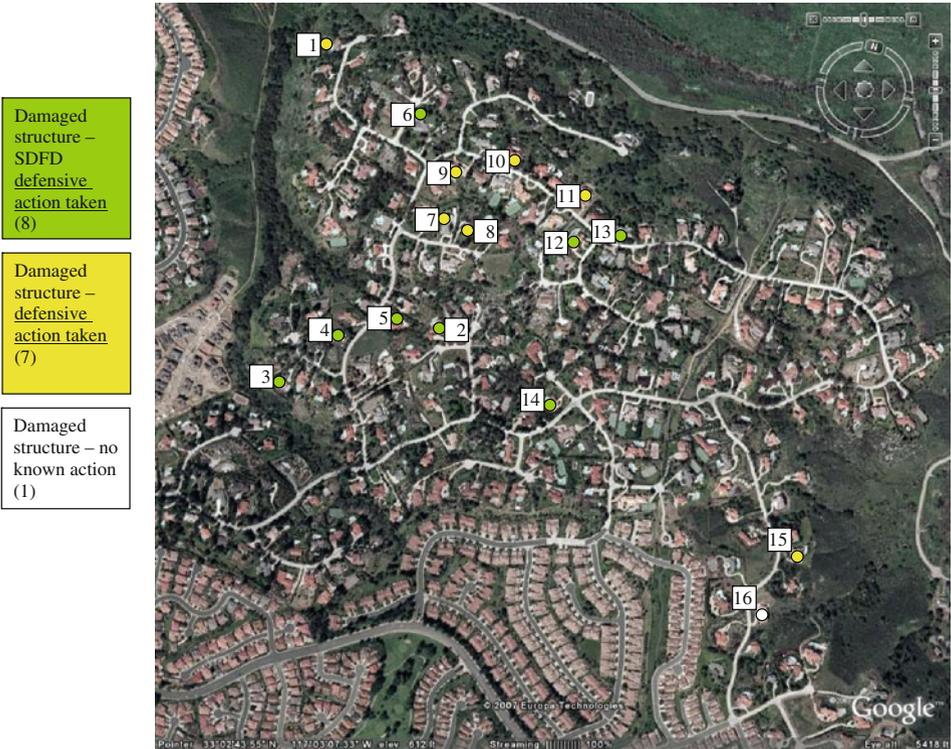
Figure 25. Damaged structures. See Table 6 for further information on each house according to number on figure.

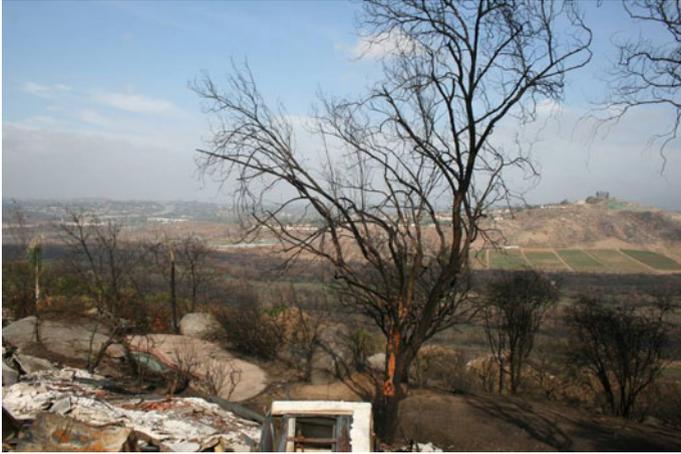
Figure 27. Structure ignition category A.

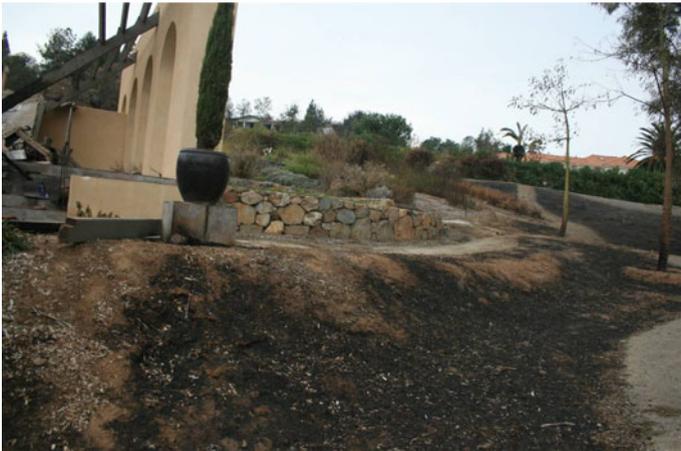
Figure 28. Structure ignition category B.

Category B was defined as structures where there was burned vegetation sufficiently close to the structure to be a potential source of structure ignition. However, the burned vegetation near the structure was not ignited due to continuous fire spread through vegetative fuels (i.e., further from the structure there was surrounding unburned vegetation). In this case, it was assumed that the vegetation

near the structure was ignited via embers. Figure 28 shows an example of a category B structure. Embers were involved in either igniting residential vegetation or directly igniting the structure (which then ignited the vegetation near the structure). Table 7 shows that the 35 structures in category B were not limited to the interior of the community, with almost one out of every three being on the perimeter of The Trails.

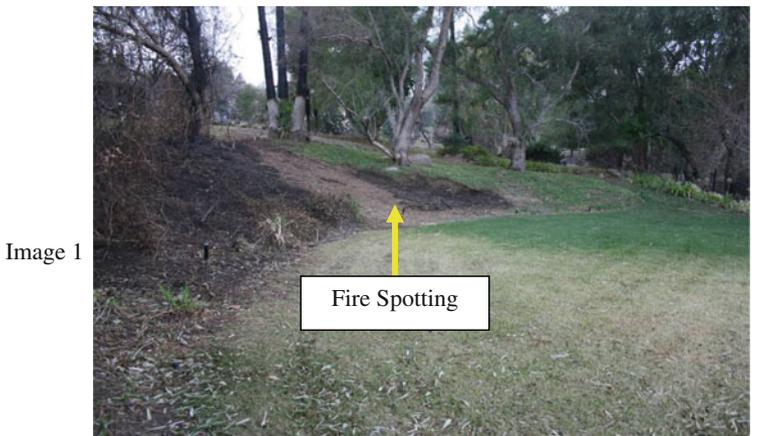
Fire spotted to vegetation next to structure and possibly onto structure

Figure 29. Structure ignition category C (Images 1, 2).
